CRITICAL AREAS REPORT

**Route 99 LLC -
Lynwood, Washington**

July 23, 2024

Title: Critical Area Report
Route 99 LLC
Lynnwood, Washington

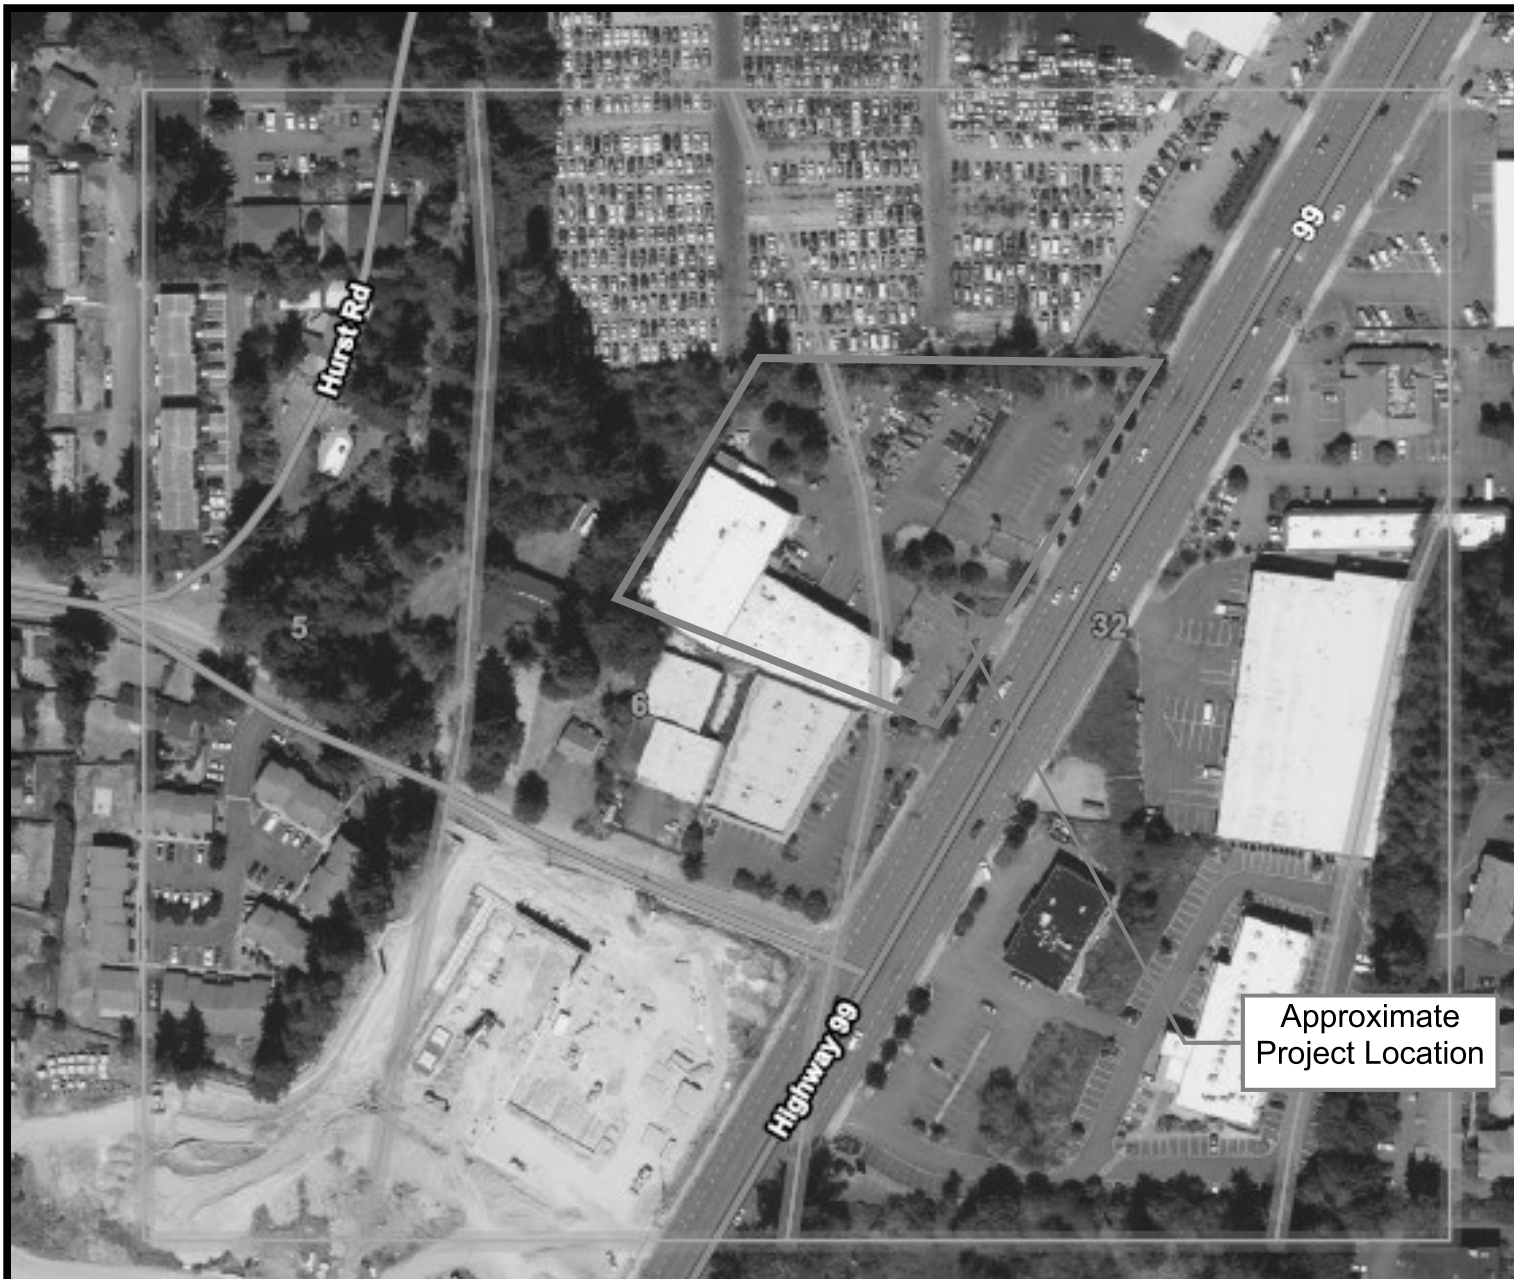
FIGURE 2 - NRCS Web Soil Survey Map Martin, Lynwood ,WA

The USDA NRCS (2023) Web Soil Survey (Figure 2) identifies Alderwood gravely sandy loam and McKenna soils in the project site. Alderwood soils are not listed as a hydric soil on either the state or national hydric soils list but may contain potential hydric soils inclusions such as McKenna, Shalcar, and Norma soil series (U.S.D.A. NRCS 2021; U.S.D.A. Soil Conservation Service 1991, Federal Register 1995). As noted above, McKenna soil series are hydric soils as identified by the U.S.D.A. NRCS 2021; U.S.D.A. Soil Conservation Service 1991, Federal Register 1995. Soil series boundaries or mapping units are mapped from aerial photographs with limited field verification. Thus, the location and extent of boundaries between mapping units may not be accurate for a given parcel of land within the survey area.

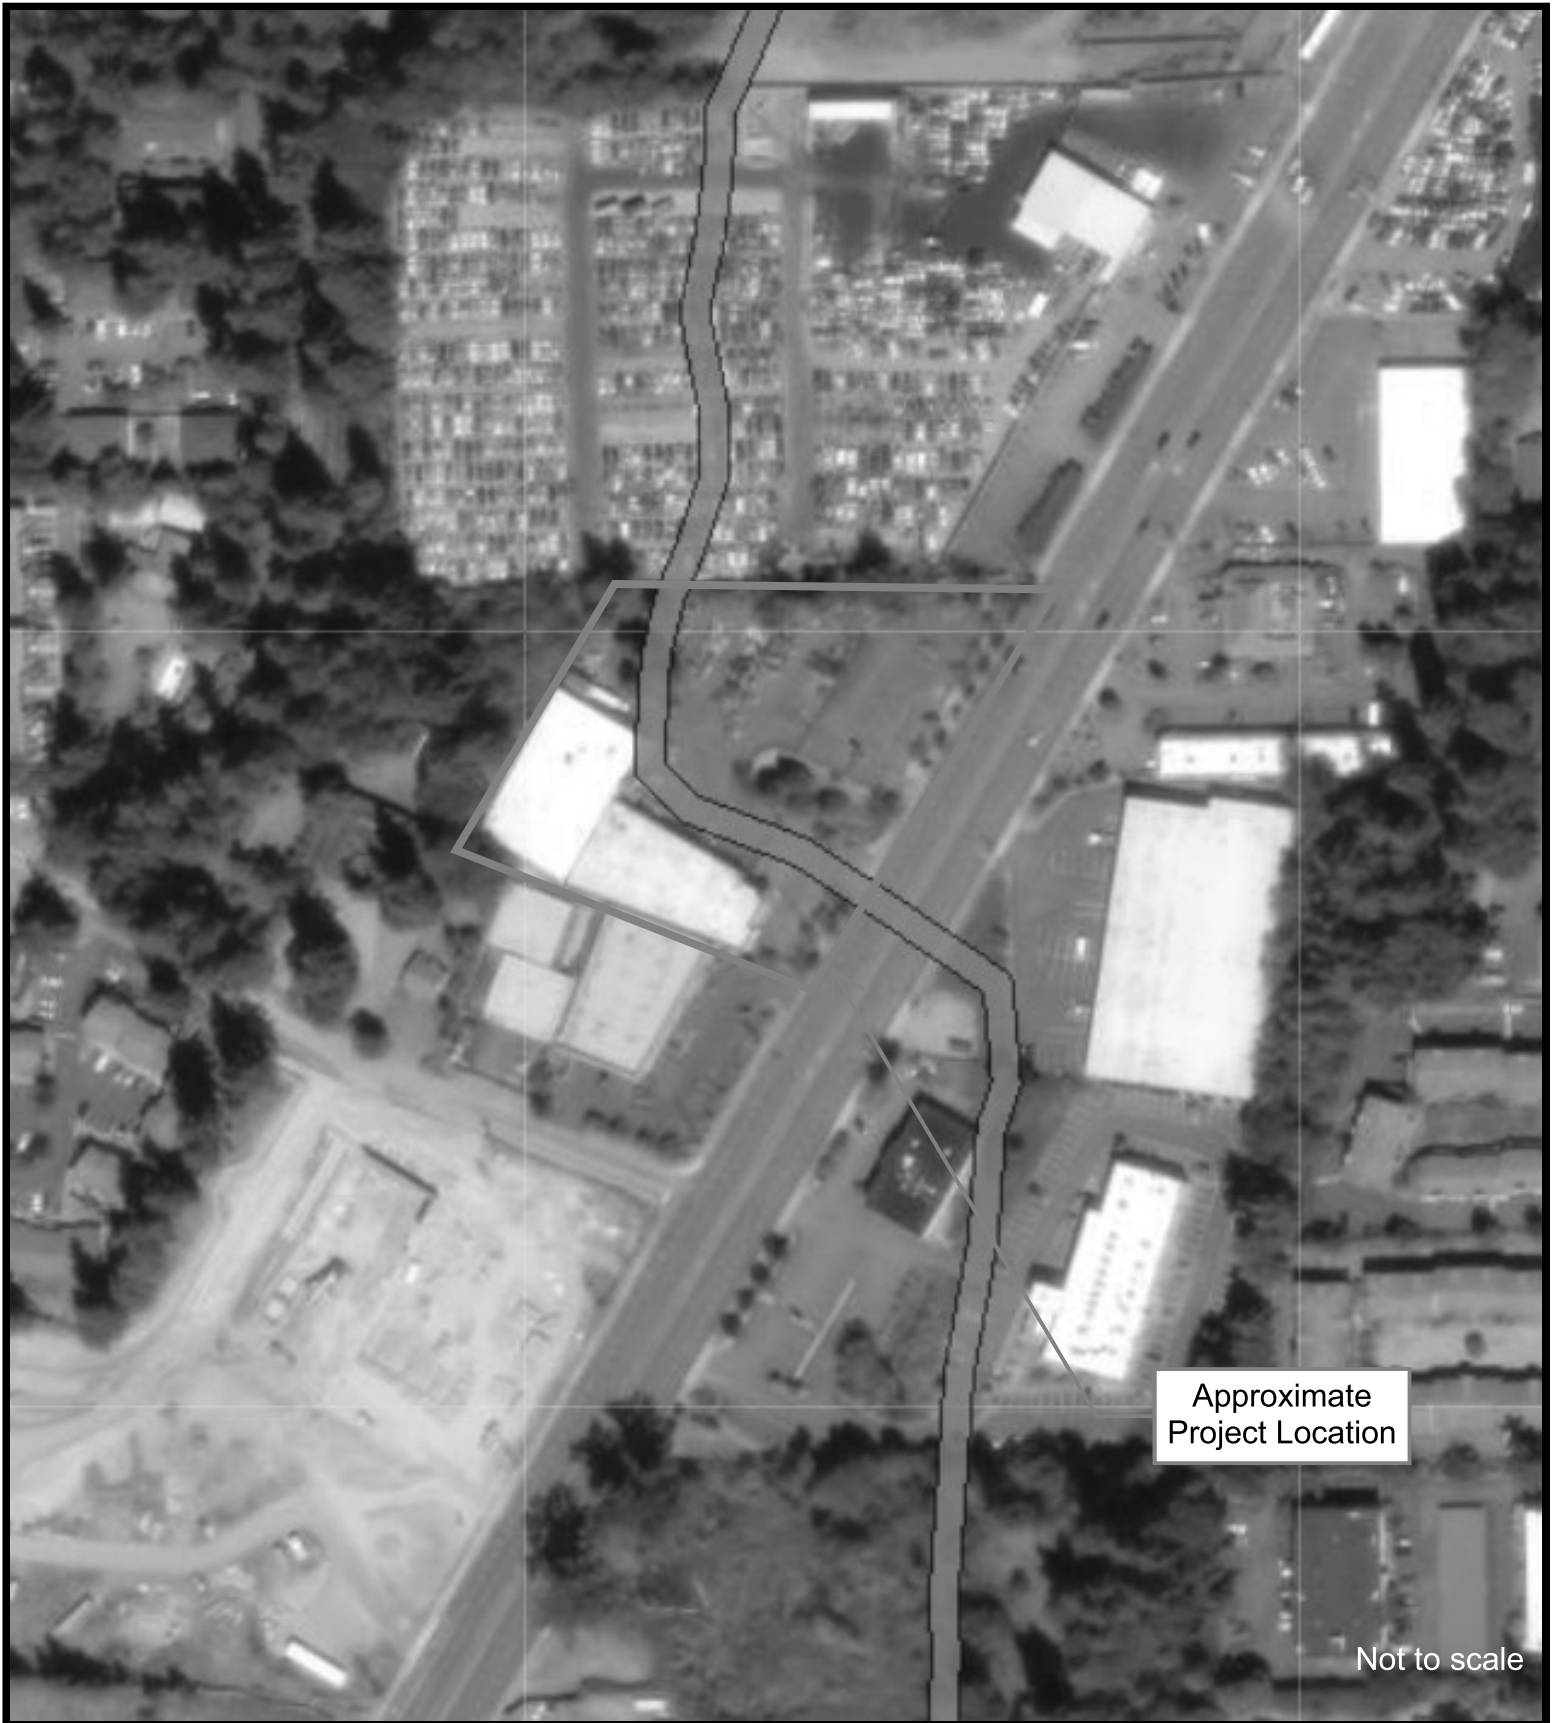
FIGURE 3 - National Wetland Inventory Map

The USFWS (2023) NWI (Figure 3) depicts a stream located in the central portion of the project site. Wetlands and streams shown on the NWI are general in terms of location and extent, as they are determined primarily from aerial photograph interpretation. Thus, the number and extent of existing wetlands located within the project area may differ from those marked on the NWI map.

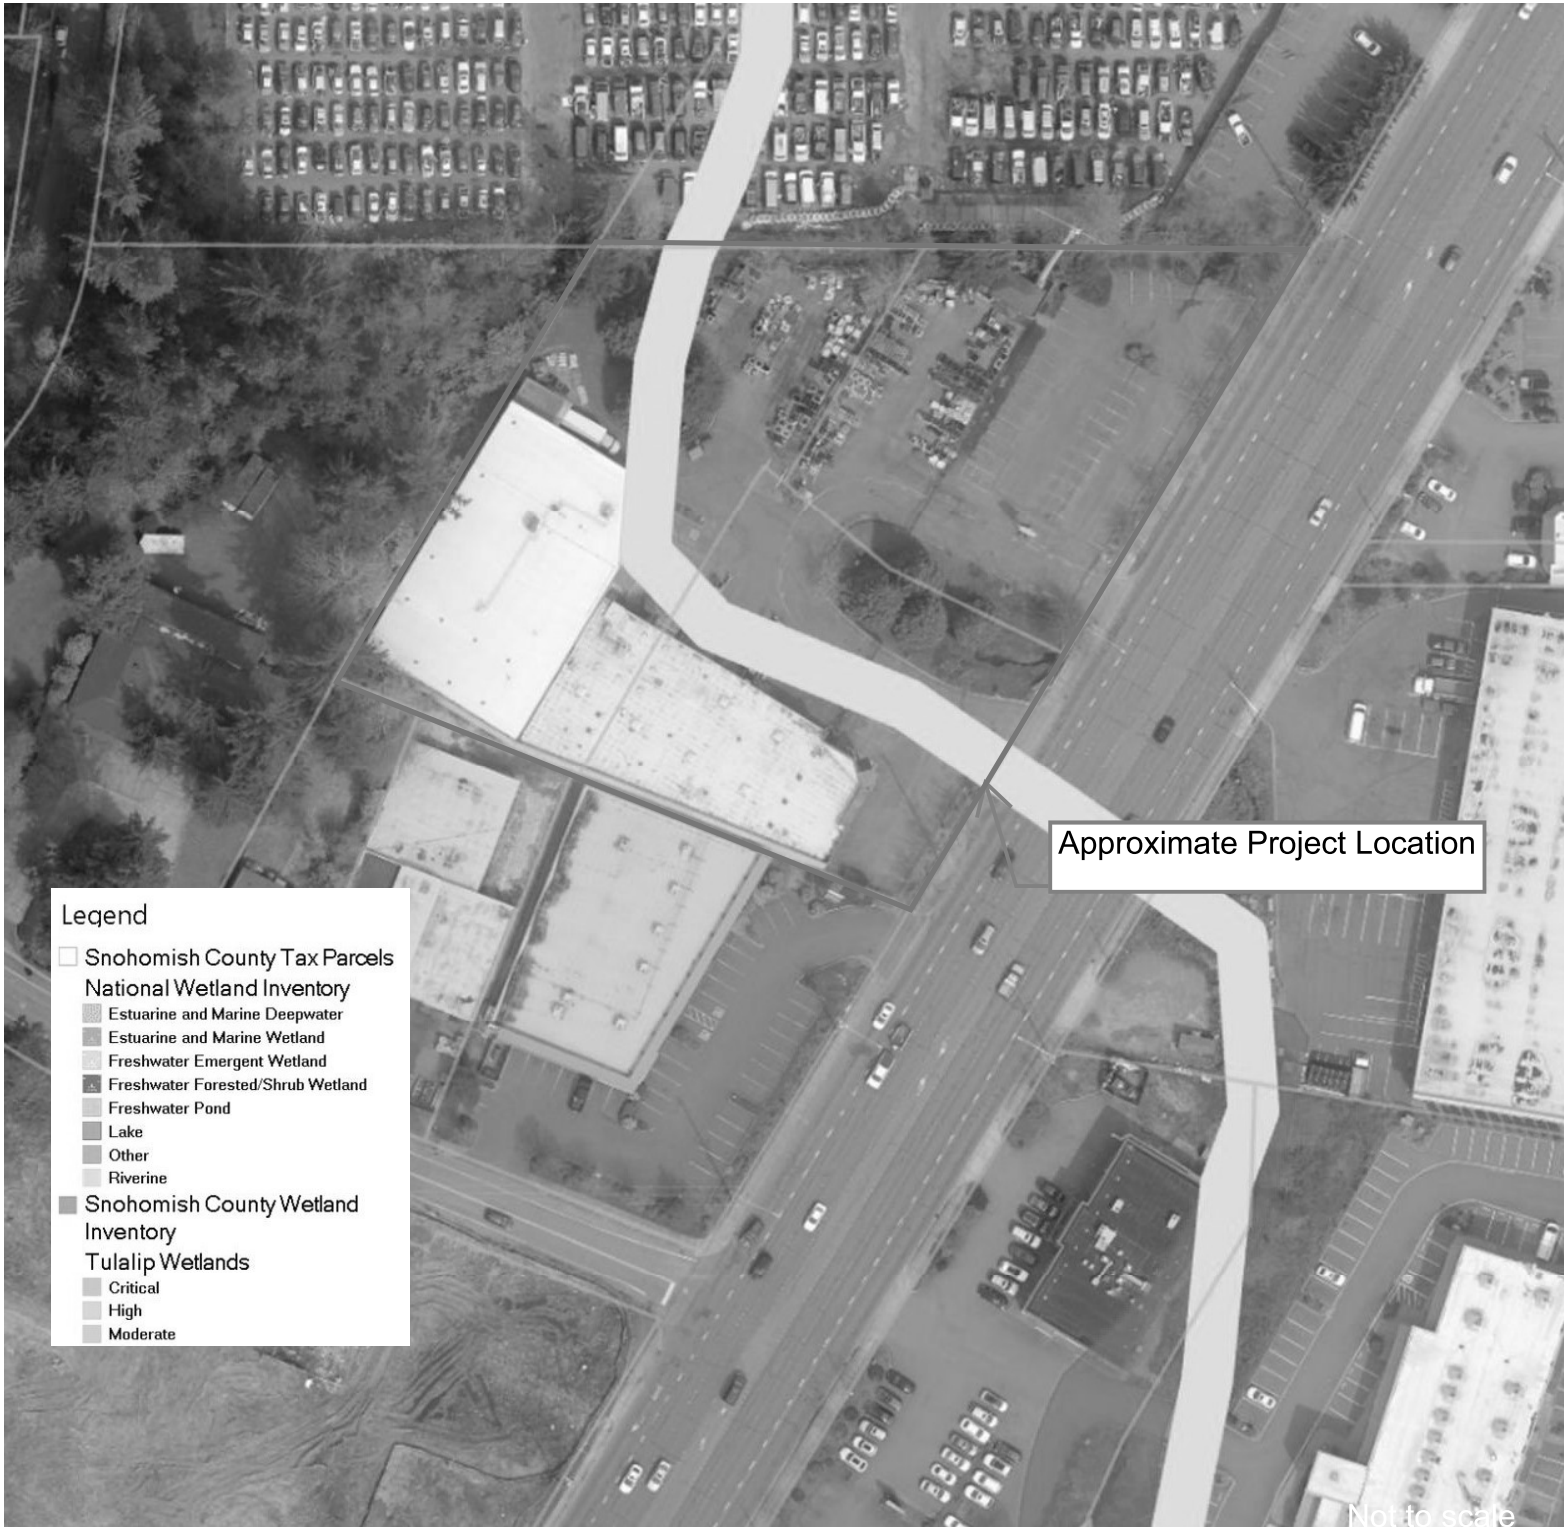
FIGURE 4 - Snohomish County Assessor Martin, Lynwood, WA

The Snohomish County (2023) PDS Map Portal (Figure 4) critical area layer depicts a stream located in the central portion of the project site in a similar location as shown on the NWI. The PDS map also depicts an off-site wetland located south of the project site and east of the Highway 99 corridor. Critical areas shown on the Snohomish County PDS map are general in terms of location and extent, as they are determined primarily from aerial photograph interpretation.

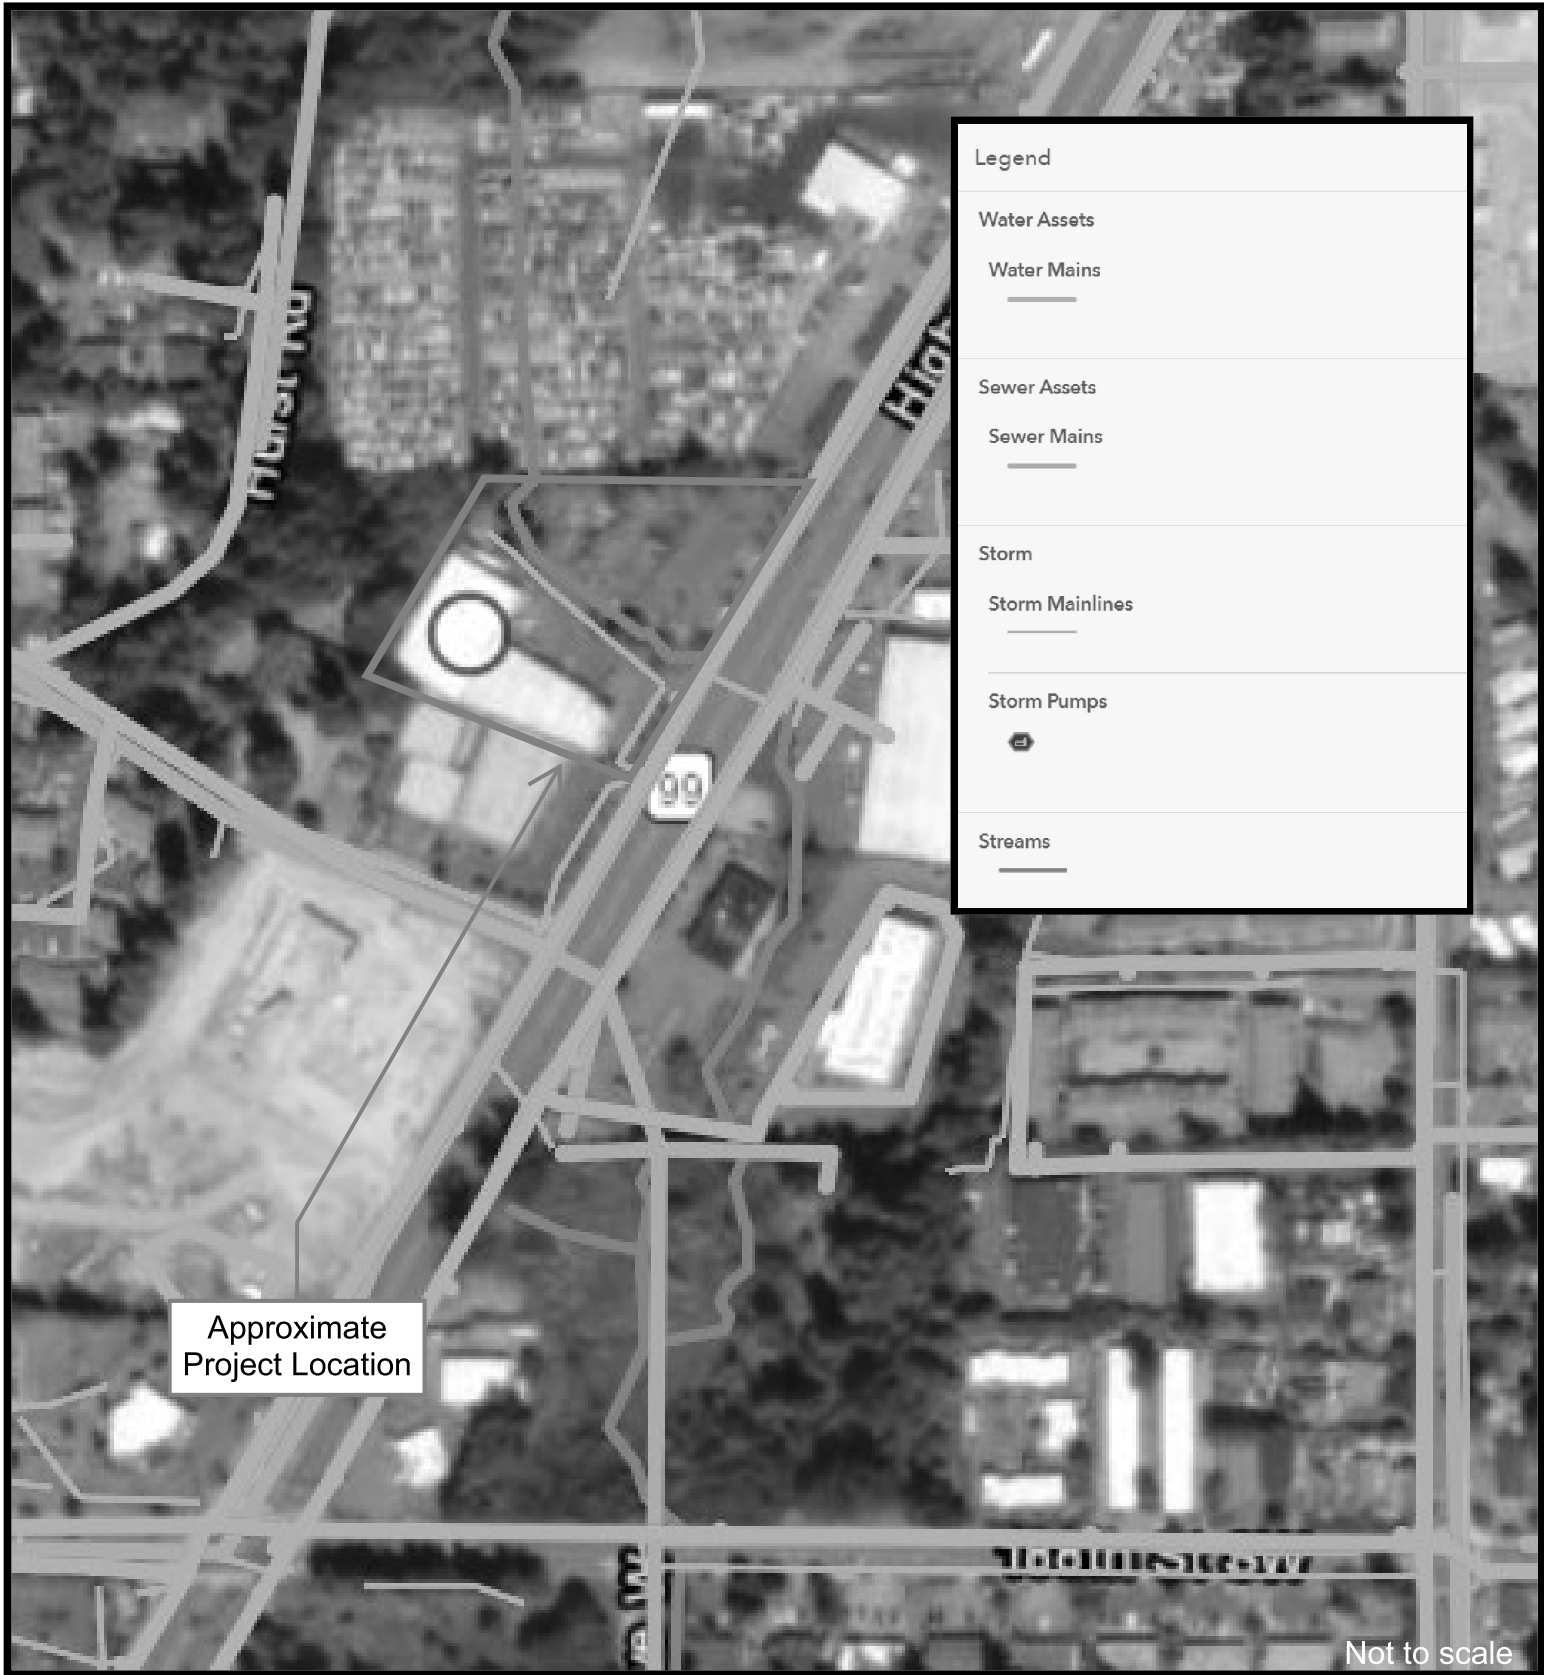
FIGURE 5 - City of Lynwood Public Map Martin, Lynwood, WA

The City of Lynwood (2014) Stream map (Figure 5) depicts Scriber Creek located on the project site. The City of Lynwood map identifies Scriber Creek as a Type F (fish-bearing) stream.

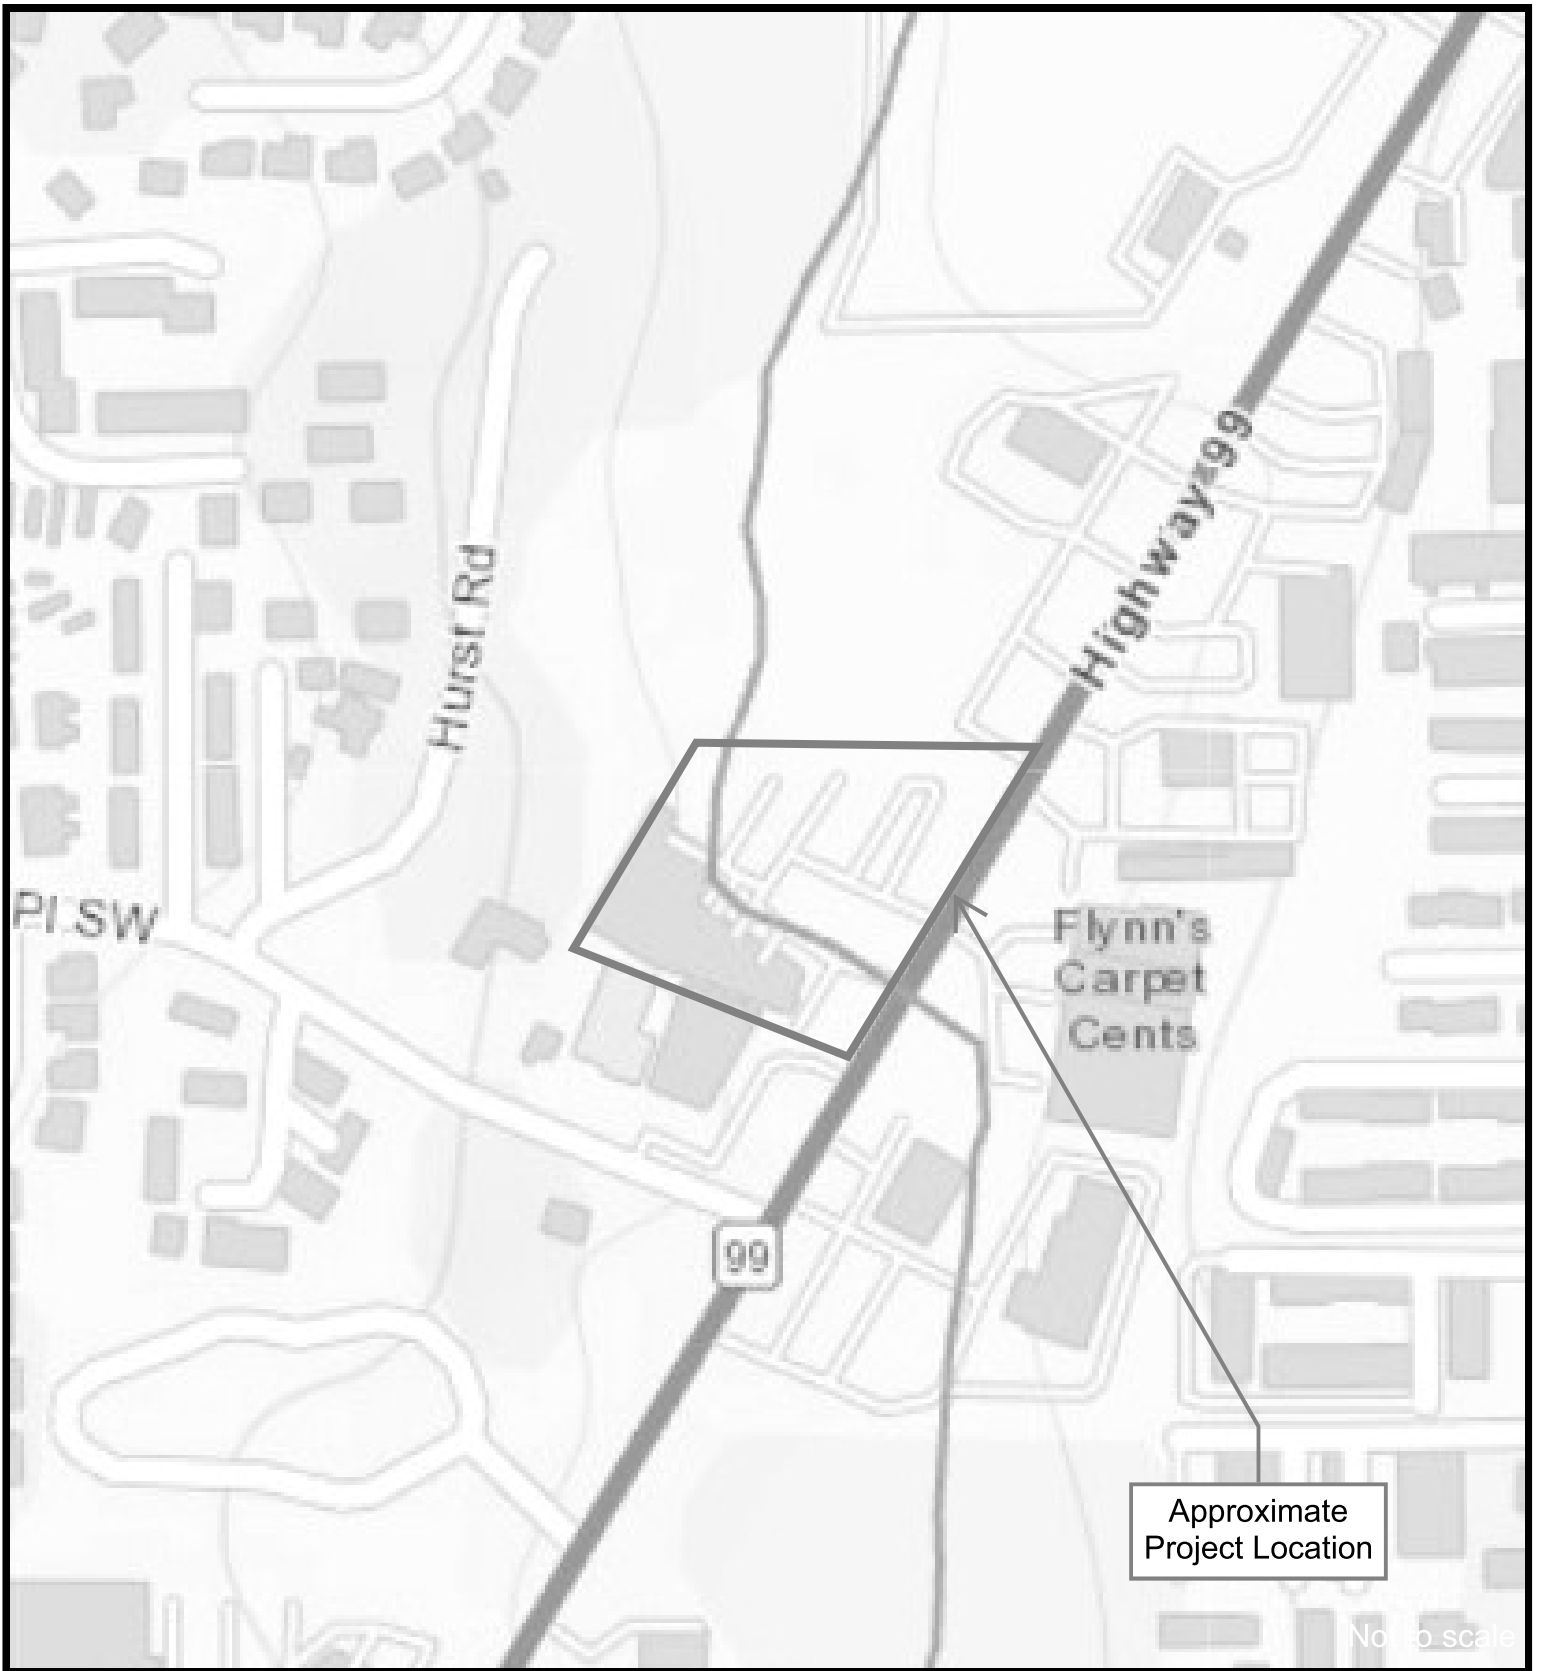
FIGURE 6 - WDFW SalmonScape

The WDFW (2023b) SalmonScape database (Figure 6) also depicts Scriber Creek in the central portion of the property in a similar location to what is depicted on the NWI and Snohomish County PDS database. The WDNR (2023) Forest Practices Application Mapping Tool Stream Type database identifies the onsite stream as a fish-bearing stream channel (Figure 7).

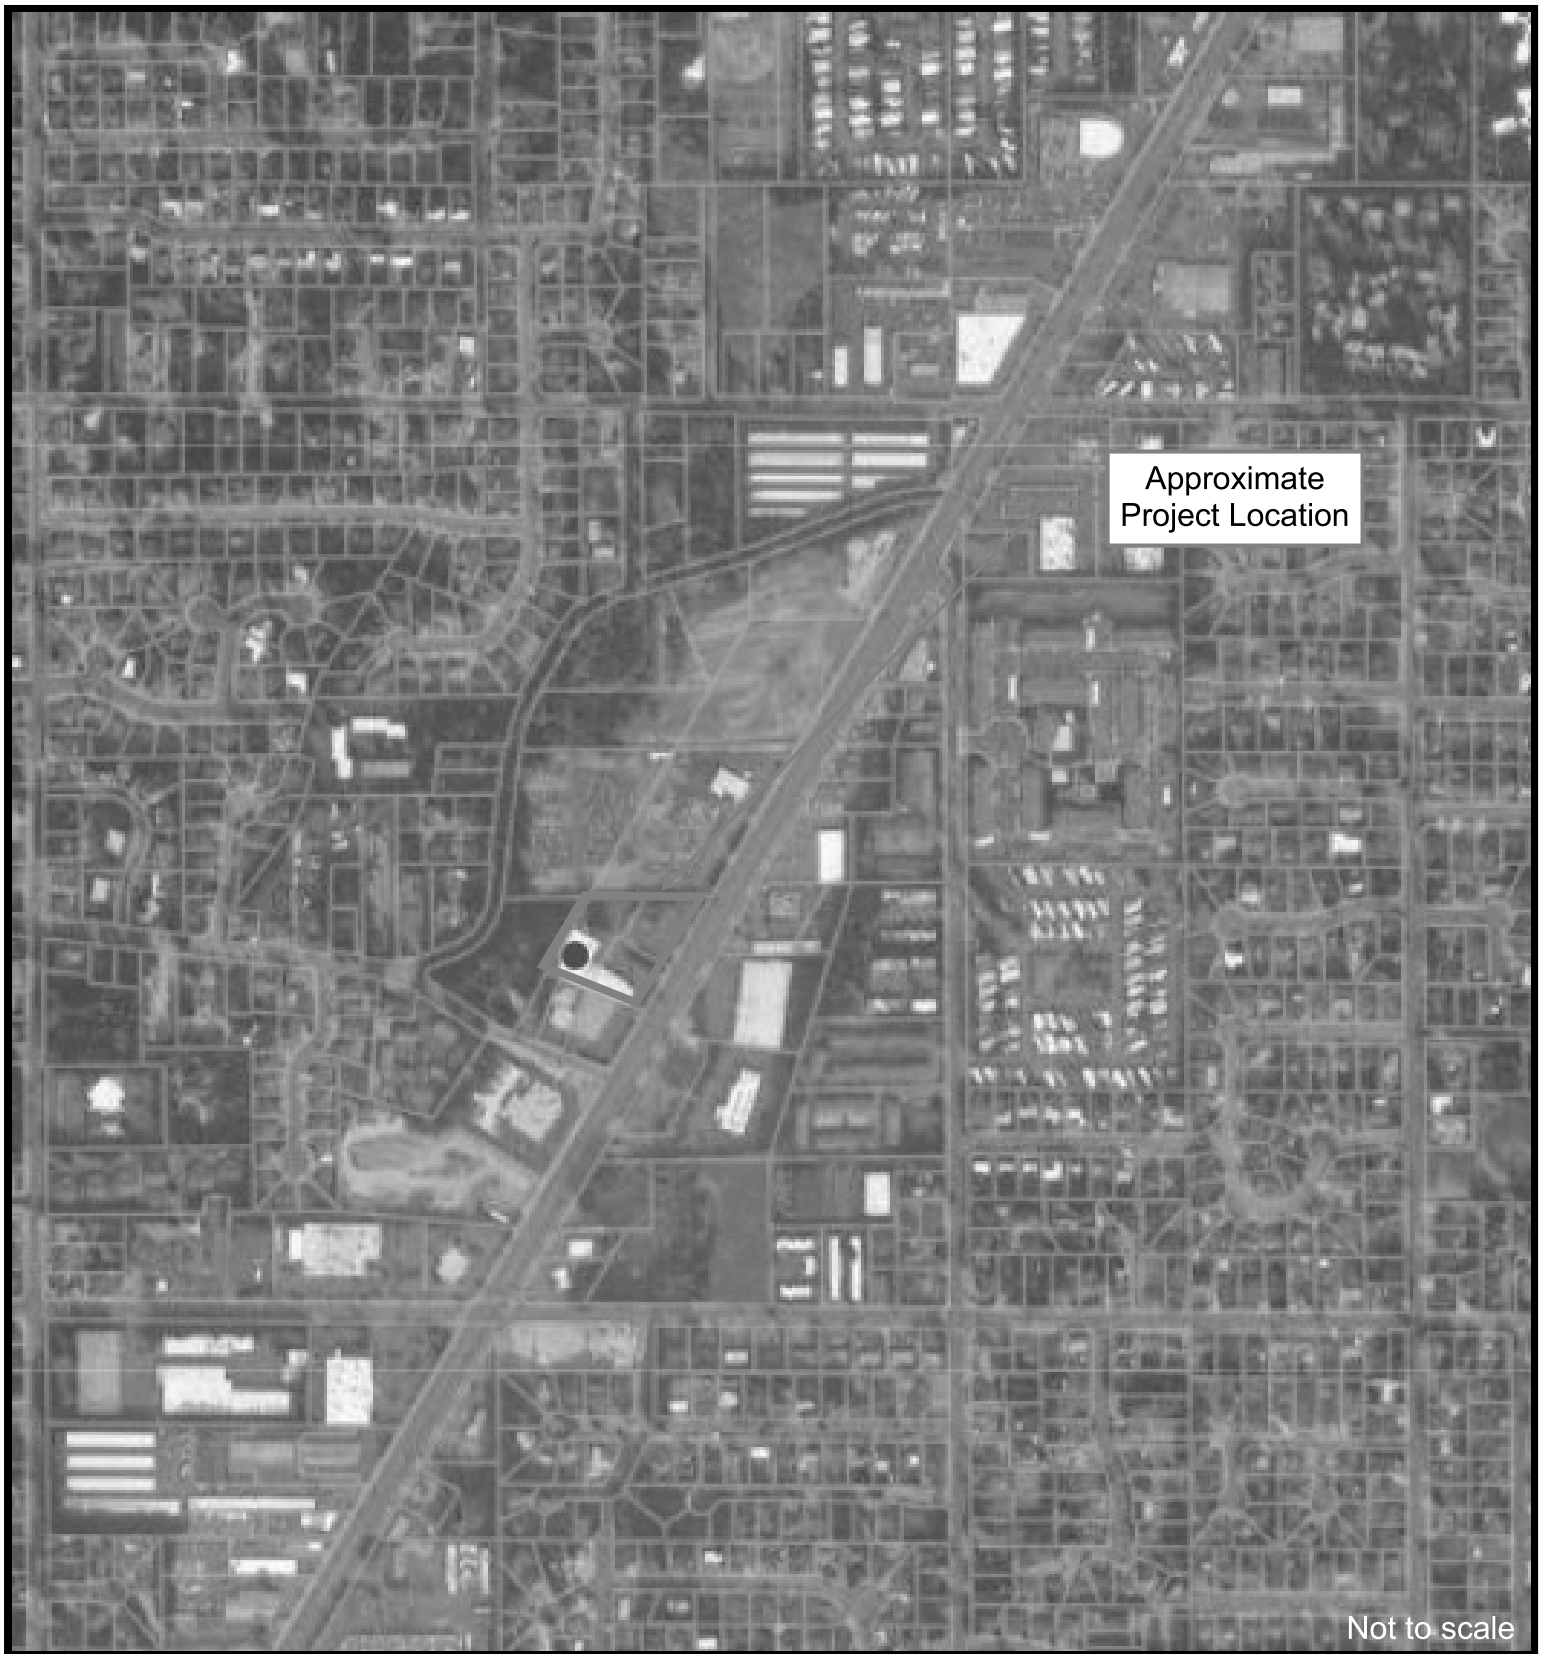
FIGURE 8 - WDFW Priority Habitats & Species

The WDFW (2021a) PHS database does not identify any mapped features on the project site. The PHS database shows a wetland off-site to the southeast of the site (Figure 8).

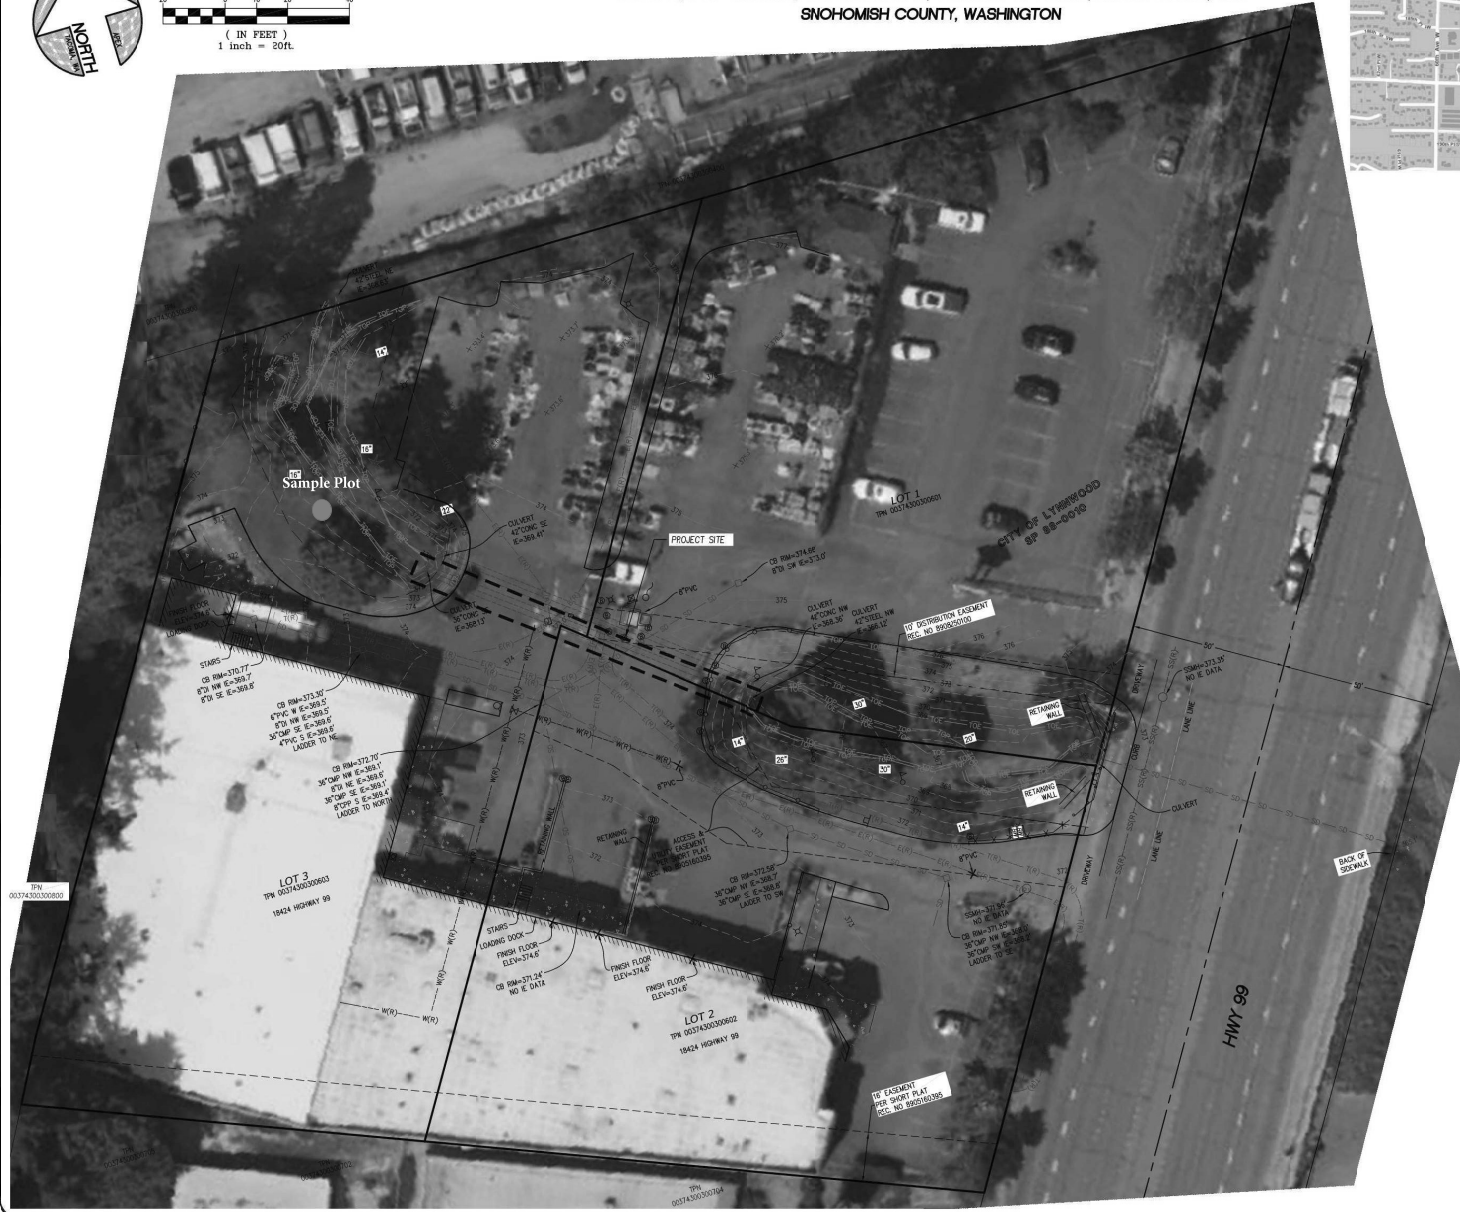
Figure 9
Existing Conditions

THERE ARE TWO CULVERTS IN THE PROJECT SITE. THE SOUTHERLY CULVERT CONSISTS OF A SEGMENT OF 36" RCP FOLLOWED BY 42" METAL PIPE. THE PURPOSE OF THIS PROJECT IS TO REPLACE THE DETERIORATED 42" METAL PIPE WITH 36" ID HDPE PIPE. THE NORTHERLY CULVERT IS ENTIRELY 42" RCP AND IS PARALLEL TO AND HIGHER THAN THE SOUTHERLY CULVERT. THE NORTHERLY CULVERT IS TO REMAIN AS IS. EXISTING TREES ARE TO REMAIN.

The project site is largely developed and contains an existing warehouse facility and office space in the south half of the site and a paved parking and storage yard in the north half of the site. The only undeveloped portions of the site are associated with a stream channel in the northwest corner of the property and the east-central portion of the site. Undeveloped portions of the site contain an overstory of Douglas-fir (*Pseudotsuga menziesii*, FACU) trees with an understory of Kentucky bluegrass (*Poa pratensis*, FAC), common dandelion (*Taraxacum officinale*, FACU), creeping buttercup (*Ranunculus repens*, FAC), and white clover (*Trifolium repens*, FAC) (Sample Plot 1; Figure 9).

The project proposes to repair the existing culvert which is partially collapsed and failing. The proposed repair will include installing a slip-line sleeve liner to support the existing culvert. This process would insert a new HDPE pipe into the existing metal pipe. The inside diameter of the new pipe would be 36 inches and would match the diameter of the existing pipe segment, thus providing support. This process would be considered an emergency maintenance activity and would be completed with the approval of a WDFW HPA expedited permit. A plan set prepared by Apex Engineering (2024) detailing the project approach is included in Appendix B of this report. As a requirement of the emergency maintenance work, it is our understanding that WDFW would require the design and installation of a permanent fish-passage culvert that will be installed at a future time. The design of the fish passage culvert will comply with WDFW requirements and be reviewed and approved by WDFW.

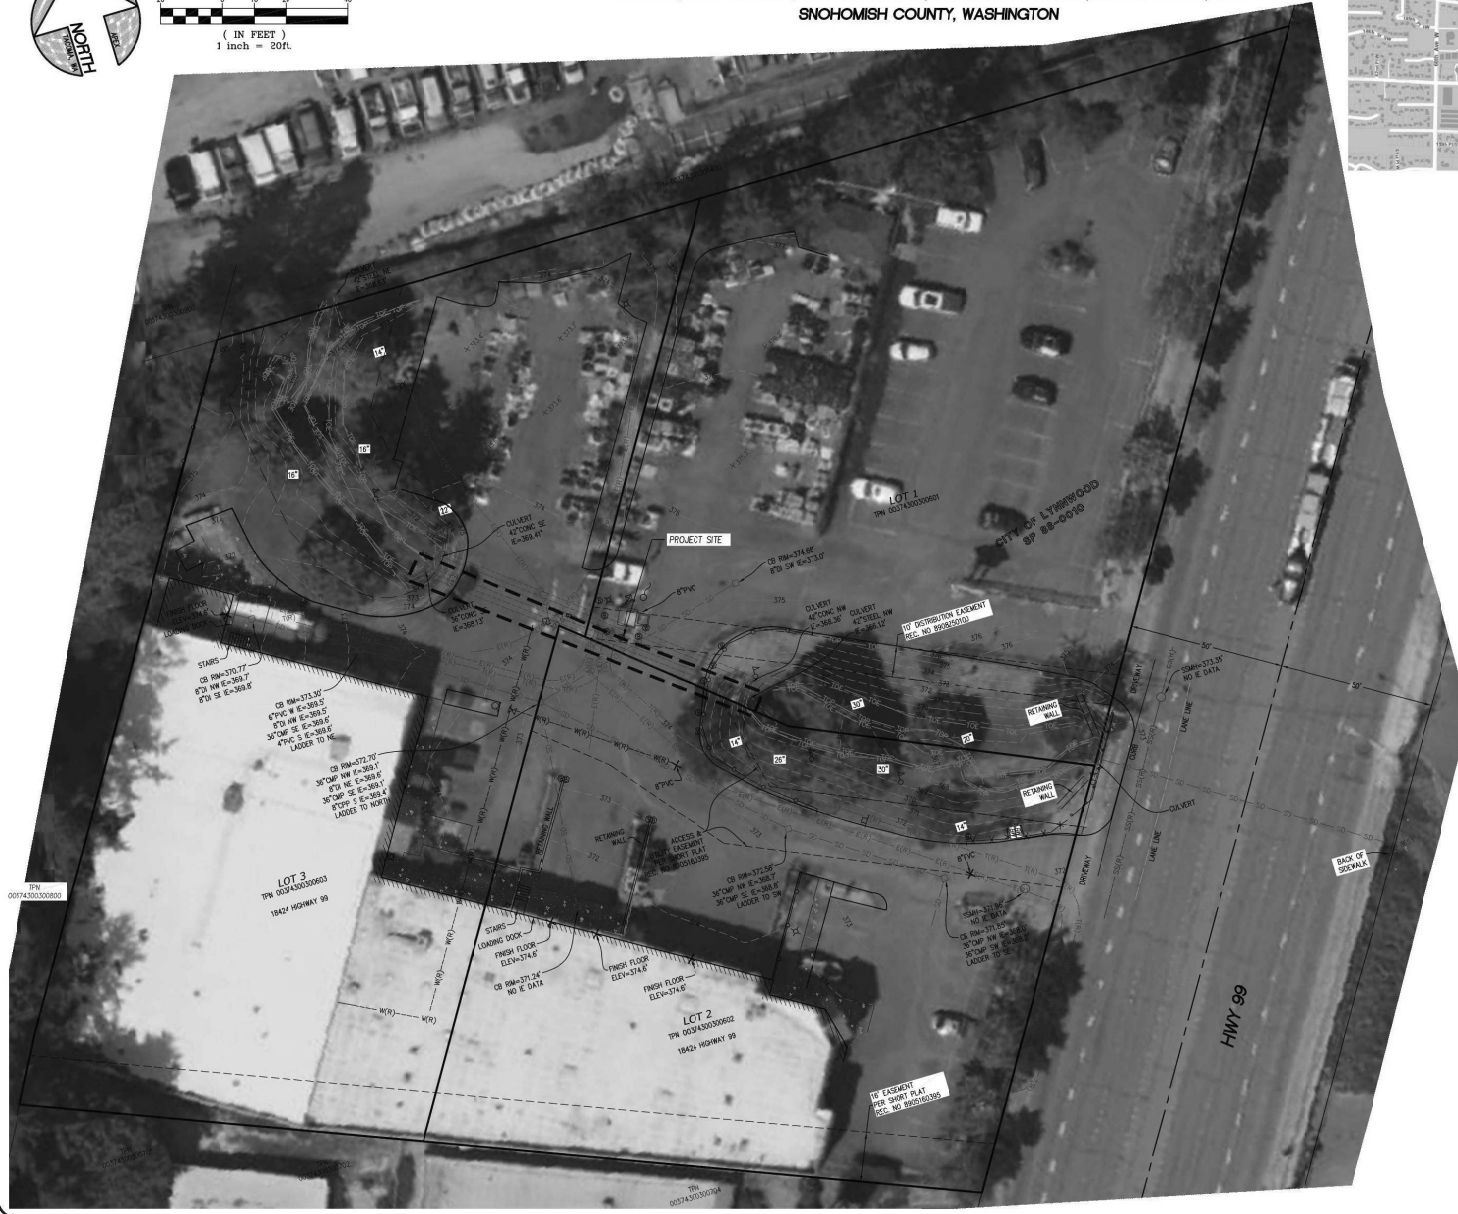
MARTIN CULVERT REPAIR
COVER SHEET, EXISTING SITE PLAN/SURVEY

THERE ARE TWO CULVERTS IN THE PROJECT SITE. THE SOUTHERLY CULVERT CONSISTS OF A SEGMENT OF 36" RCP FOLLOWED BY 42" METAL PIPE. THE PURPOSE OF THIS PROJECT IS TO REPLACE THE DETERIORATED 42" METAL PIPE WITH 36" ID HDPE PIPE. THE NORTHERLY CULVERT IS ENTIRELY 42" RCP AND IS PARALLEL TO AND HIGHER THAN THE SOUTHERLY CULVERT. THE NORTHERLY CULVERT IS TO REMAIN AS IS. EXISTING TREES ARE TO REMAIN.
